FHWA/IN/JTRP-2009/34

Final Report

**INNOVATIVE BRIDGE CONSTRUCTION
PROGRAM: IMPLEMENTATION OF FULL-DEPTH
BRIDGE DECK PANELS IN INDIANA**

March 2010

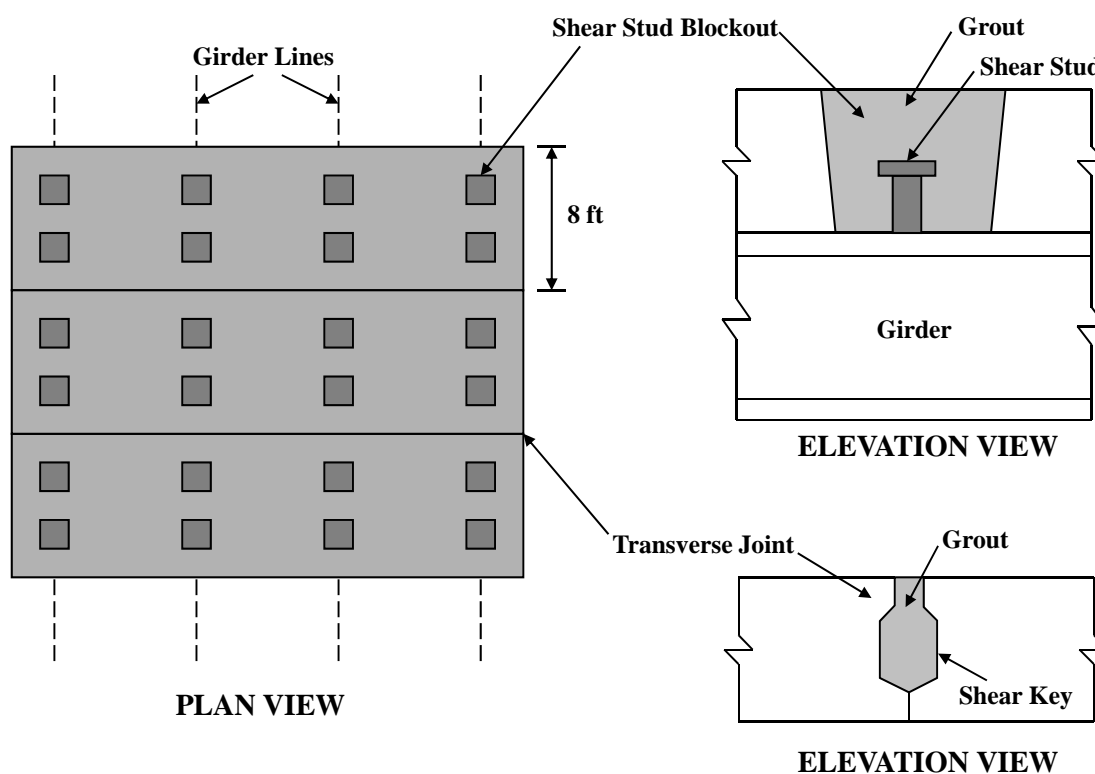
A schematic of a typical precast panel system is shown in Figure 1.1. As illustrated, precast deck panels are typically constructed with the full design depth of the deck and span the full transverse width of the bridge. In the longitudinal direction, panels are typically 8 ft in length because of transportation limitations. The connection between adjacent panels is accomplished by the use of shear keys. For connection to the girder, block outs in the panels, referred to as shear stud pockets, are commonly provided.

Figure 1.1: Typical full-depth precast bridge deck panel system

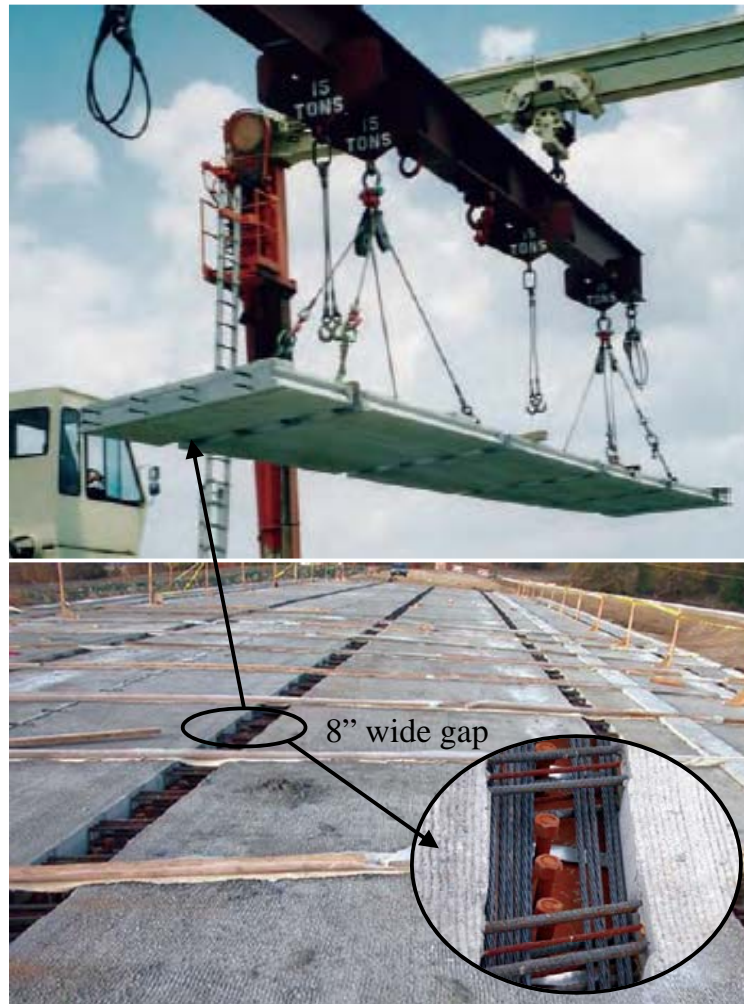
This non-proprietary system was developed at the University of Nebraska (Badie et al. 1998). The system was originally a continuous partial depth system, but quickly evolved into a full-depth system (Versace 2003). The deck panels are typically 6 in. thick and use a female-to-female transverse joint similar to that shown in Figure 1.1. The connection to the supporting structure is accomplished through an 8 in. wide gap over the girder that runs the length of the panel. This system requires prestressing in the transverse directions because of the reduced thickness. A typical NUDECK panel is shown in Figure 1.2.

Figure 1.2: Typical NUDECK panel (Fallaha et al. 2004)

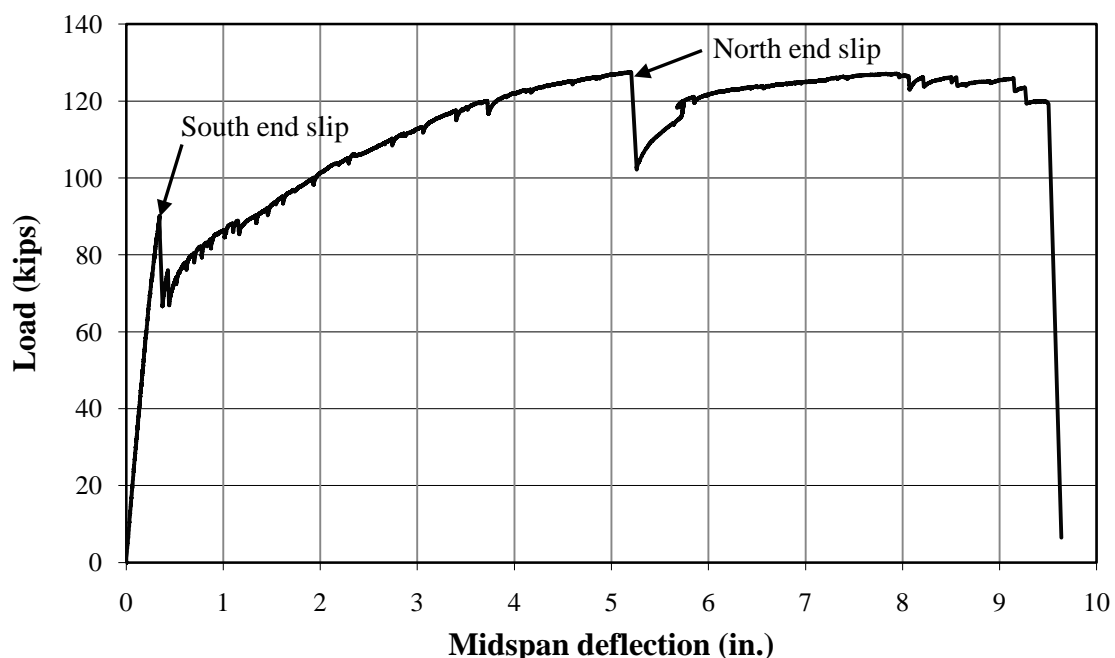
The load-deflection response for Specimen 4-1 is presented in Figure 2.15. As evident, the specimen behaved as a composite section up to a load of approximately 89 kips at which bond failure occurred at the girder-haunch interface along the south half of the specimen. Bond failure is evident in considering the horizontal slip on the south side of midspan (Figure 2.16). Loading of the specimen continued to 127 kips at which bond failure occurred at the girder-haunch interface along the north half of the specimen. Again, bond failure on this side is evident in considering the horizontal slip on the north side of midspan (Figure 2.17). A maximum measured slip, prior to failure, of 0.68 in. occurred at the 1/8 north span. Measured strains (Figure 2.18) indicate that the shear studs yielded prior to specimen failure. Failure of the specimen occurred at 119 kips and 9.5 in. midspan deflection. Final failure occurred by failure of the shear studs along the north side of the specimen, as shown in Figure 2.19, which was immediately followed by flexural failure of the girder due to crushing of the compression zone. It should be noted that crushing of the panels was not observed.

Figure 2.15: Load vs Midspan deflection – Specimen 4-C

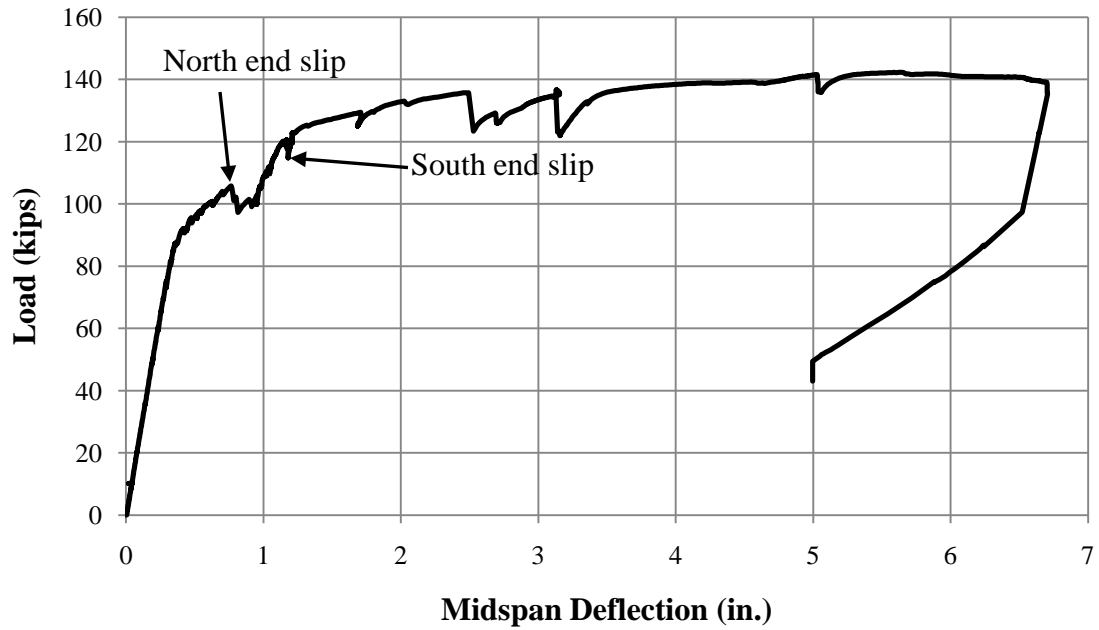
evident from the flexural cracks at the bottom of the precast panel, the girder and deck were not acting fully composite at this stage. Shear failure of shear studs was not observed.

Figure 2.20: Load vs Midspan Deflection – Specimen 6-C

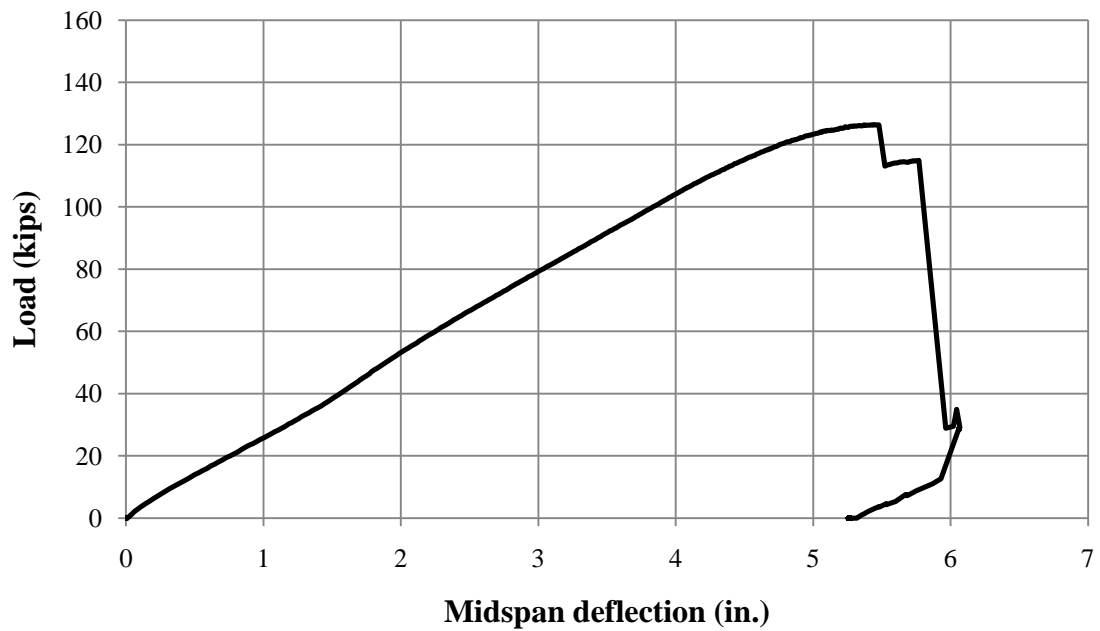
Figure 2.24: Load vs Midspan deflection for final loading to failure – Specimen 6-C

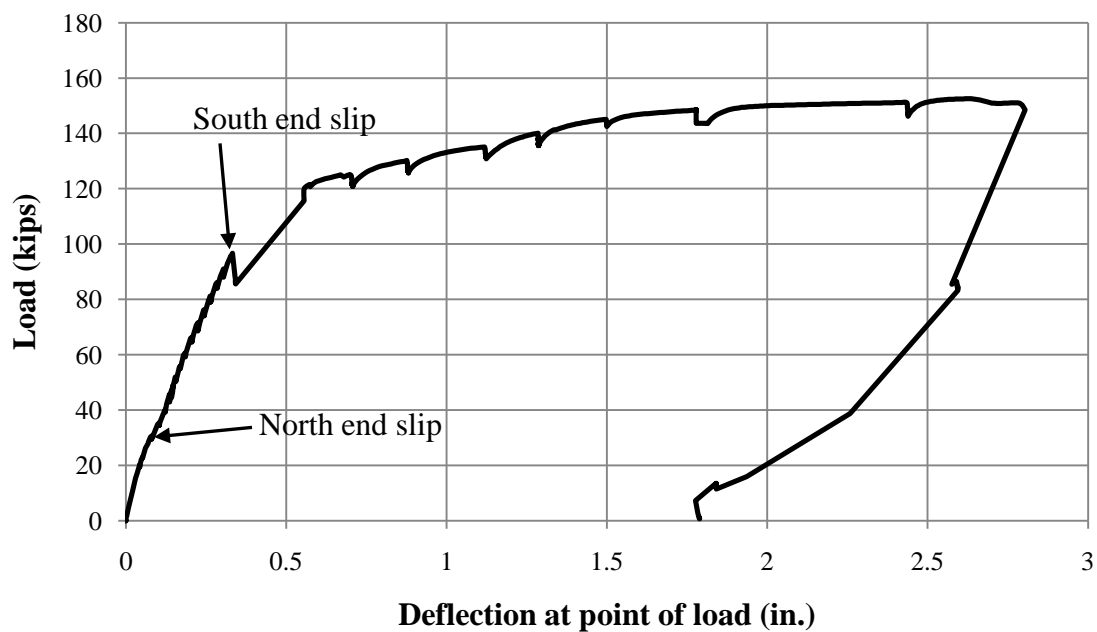
The load-deflection response from Test 1 of Specimen 4/6-P is presented in Figure 2.26. The specimen behaved as a composite section up to a load of approximately 30 kips at which bond failure occurred at the girder-haunch interface along the north side of the load location. Bond failure is evident in considering the horizontal slip on the north end of the specimen (Figure 2.27). Loading of the specimen continued to approximately 97 kips at which bond failure occurred along the south end. Again, bond failure is evident in considering the horizontal slip on the south end (Figure 2.28). Loading of the specimen continued to a maximum load of 152 kips. A maximum measured slip, prior to failure, of 0.59 in. occurred at the north slip gauge. Failure of the specimen occurred at 148 kips and 2.8 in. of deflection at the load location. Final failure resulted from failure of the compression zone of the girder section, as shown in Figure 2.29. No crushing was observed in the precast panel. In addition, shear failure of the shear studs was not observed.

Figure 2.26: Load vs deflection – Specimen 4/6-P, Test 1

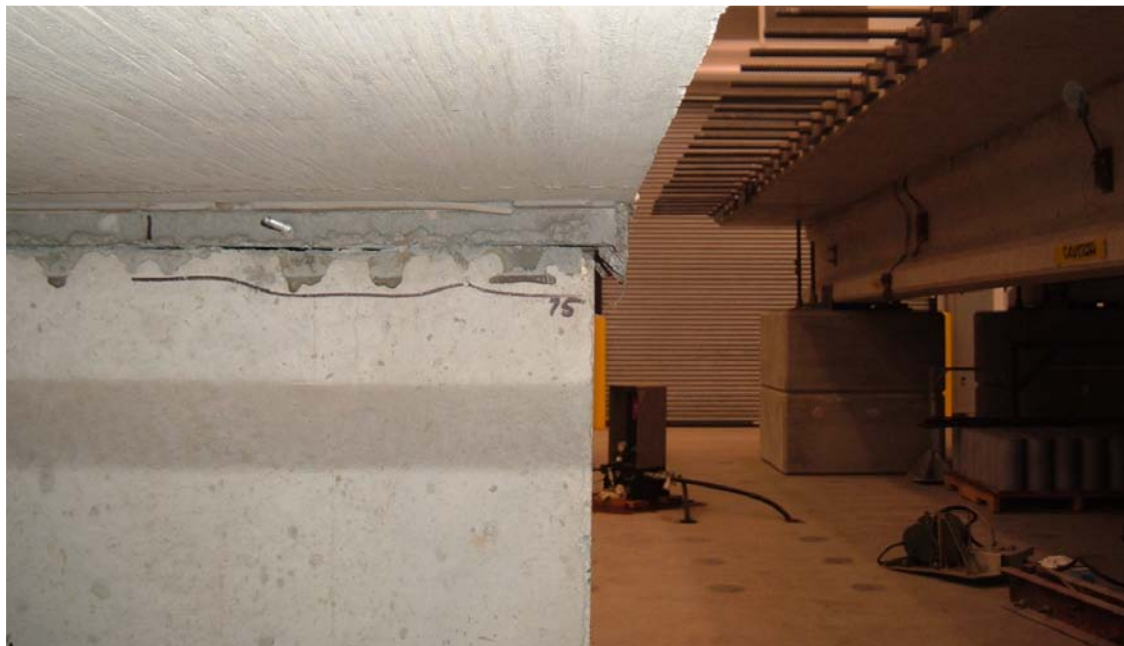
slip at North end of specimen

Figure 2.29: Failure of Specimen 4/6-P, Test 1

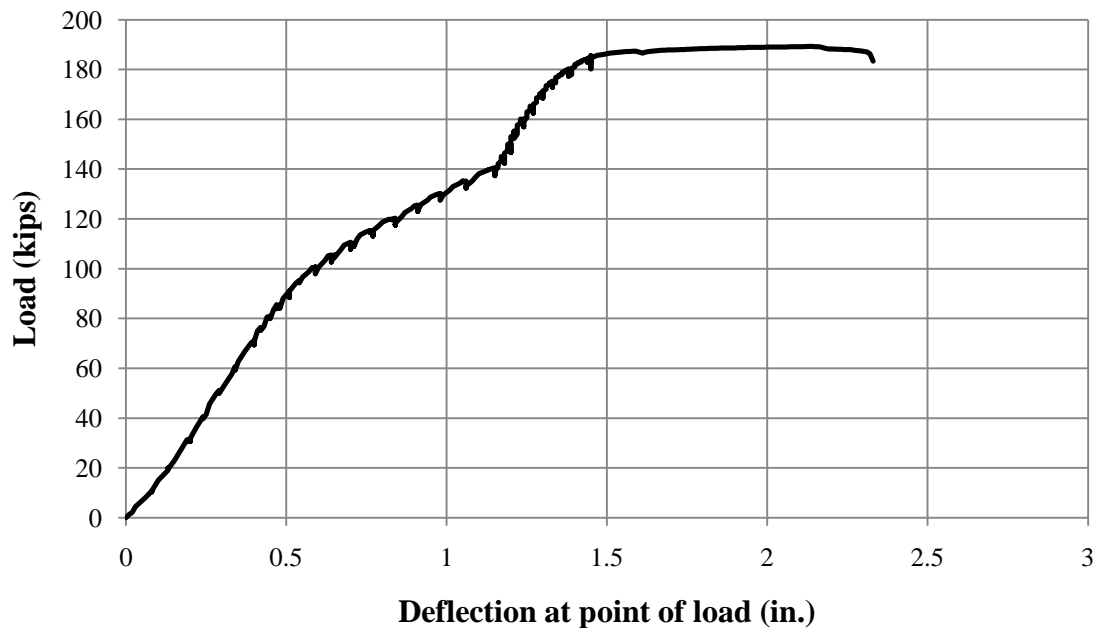
the horizontal slip measured on both the north and south sides of the loading point (Figure 2.31). The starting displacement of each slip measurement (Figure 2.31) is from the residual of Test 1 (Figure 2.28). The specimen was loaded to a maximum load of approximately 189 kips. A maximum measured slip, prior to failure, of 0.7 in. occurred at the south slip gauge. Failure of the specimen occurred at 183 kips and 2.3 in. of deflection at the loading location. Final failure occurred by shear failure of the studs along the south shear span, as shown in Figure 2.32. This failure was immediately followed by flexural failure of the girder due to crushing of the compression zone. No crushing of the deck panels was observed.

Figure 2.30: Load vs deflection – Specimen 4/6-P, Test 2

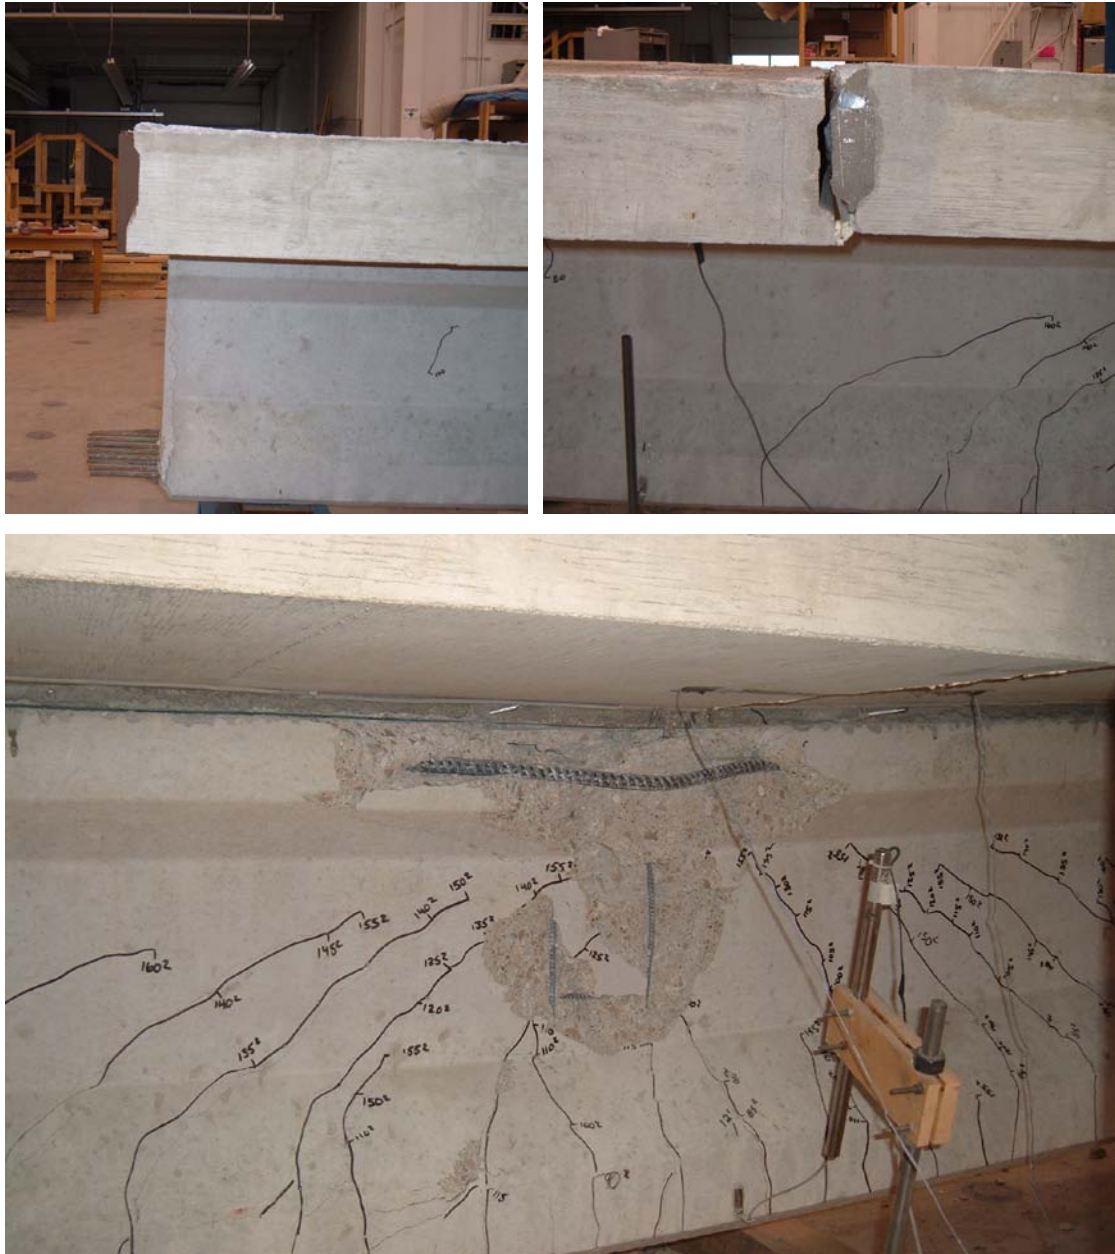
Figure 2.32: Failure of Specimen 4/6-P, Test 2

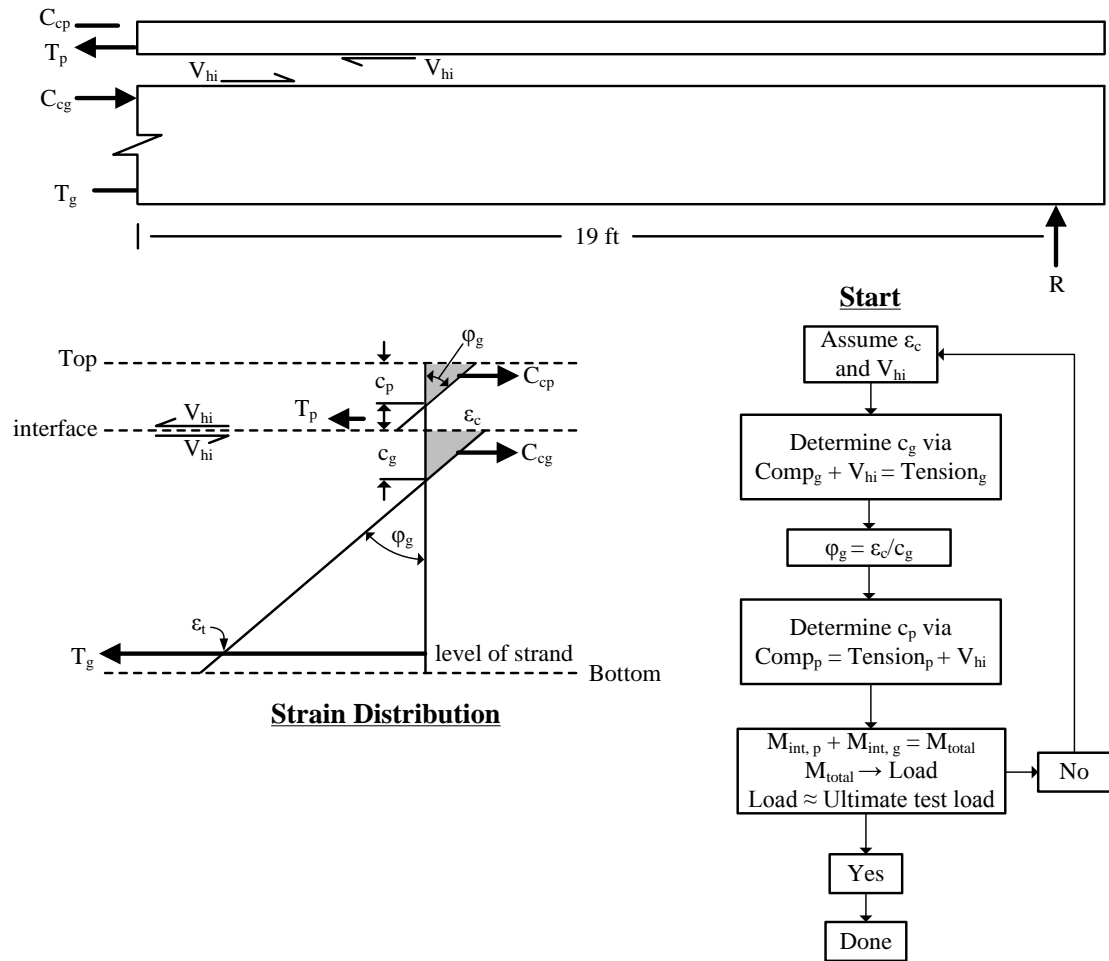
The partial-composite analysis described can also be used to determine the area of steel required across the shear plane to develop the full-composite capacity of the section. The area can be determined by computing the full-composite capacity and then

Figure 2.34: Determining shear force at horizontal interface, partial-composite

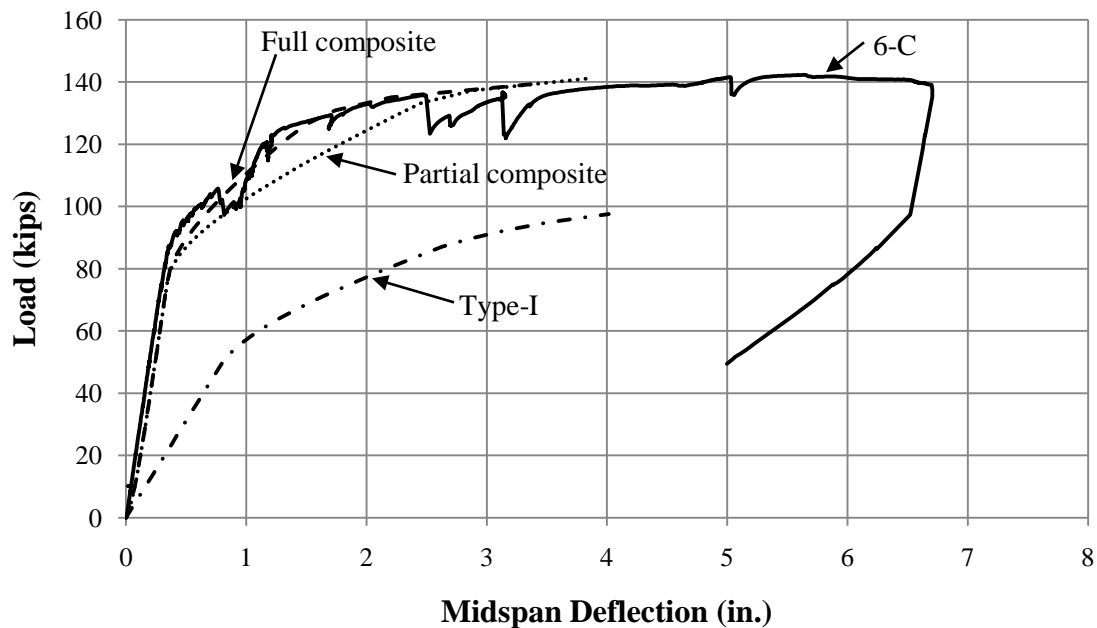
throughout the test. This result was unexpected since the specimen was partial-composite once bond failure occurred in the north end of the specimen. However, from MC analysis of the partial-composite section, it is evident that the ultimate load capacity of the full-composite section can be achieved. The required horizontal shear capacity at the interface of the partial-composite section is 380 kips to obtain an ultimate load equal to that of the specimen. There were 10 studs in each half span, therefore, 380 kips equates to 38 kips/stud assuming the studs have yielded and contribute equally. The amount of horizontal force required to reach the full-composite load of 140 kips was 365 kips which equates to 36.5 kips/stud.

Figure 2.36: Specimen 6-C compared with computed load-deflection paths

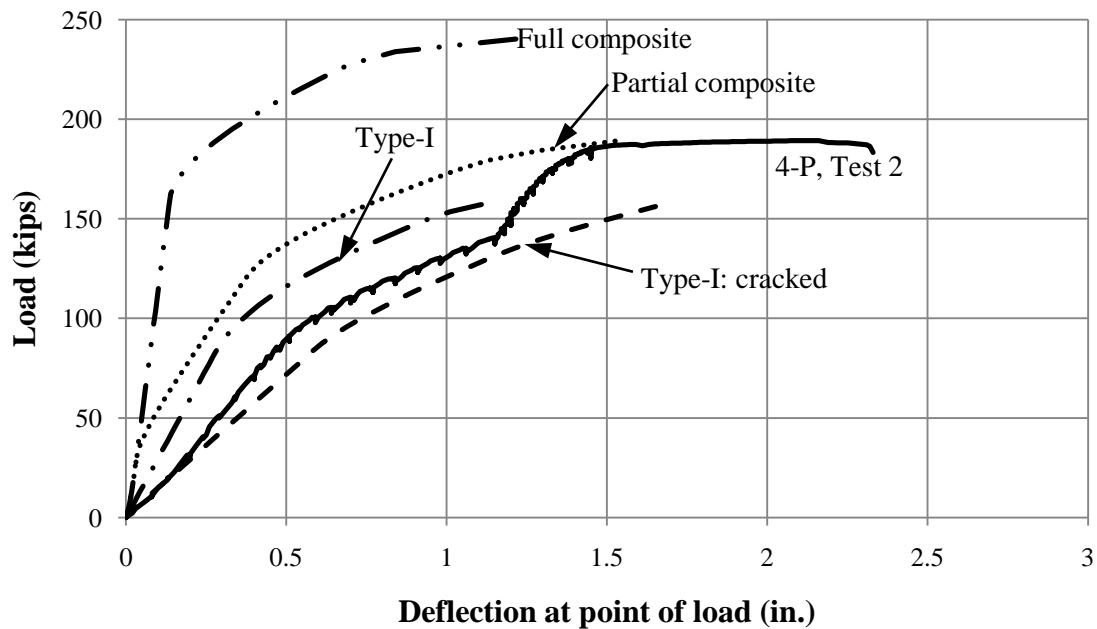
The partial-composite load path is also presented and was determined using the procedure described in Section 2.7. The force transferred at the horizontal interface (V_{hi}) was initially taken as 108 kips and was incrementally increased to 145 kips which resulted in an associated load capacity of 189.4 kips, similar to the maximum load applied to the specimen (189.2 kips). There were 6 studs in the 11 ft shear span, therefore, each stud carried 24.2 kips assuming all studs have yielded and are contributing equally. This value is similar to the 28.5 kips/stud from Specimen 4-C. However, if the developed strength per stud in Specimens 4-C and 4/6-P are normalized by the ratio of f_u of the studs (107 ksi for 4-C and 95 ksi for 4/6-P (#4 studs)), the difference in developed yield strength is reduced from 4.3 kips to 1.1 kips. It should be noted that in both tests, failure of the #4 studs occurred. These results show excellent correlation in the forces carried.

Figure 2.38: Specimen 4-P, Test 2, compared with computed load-deflection paths

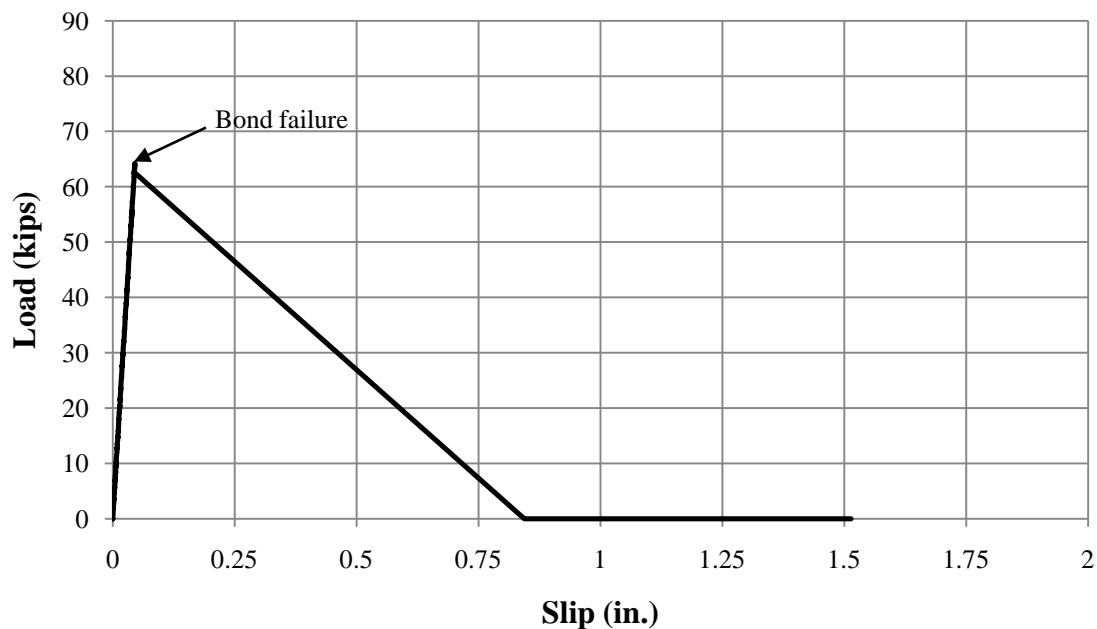
The load-slip response for Specimen 1-4000-6-4 is presented in Figure 3.13. The specimen behaved as a composite section up to a load of approximately 64.3 kips at which bond failure occurred at the trough-girder section interface. No cracking was observed prior to bond failure. A maximum measured shear stud strain of $509 \mu\epsilon$ occurred immediately after bond failure (Figure 3.14). The deck section fell away from the girder section following bond failure (Figure 3.15). Measured strains indicate that the shear stud did not yield.

Figure 3.13: Load-slip response of Specimen 1-4000-6-4

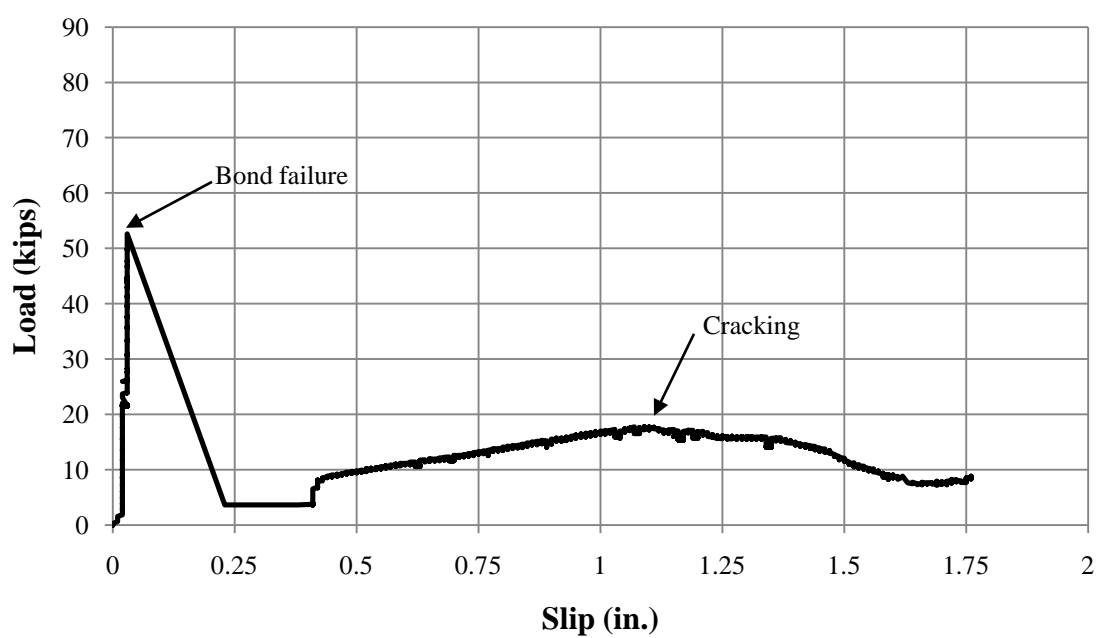
Figure 3.17: Load-slip response of Specimen 1-4000-6-k-4

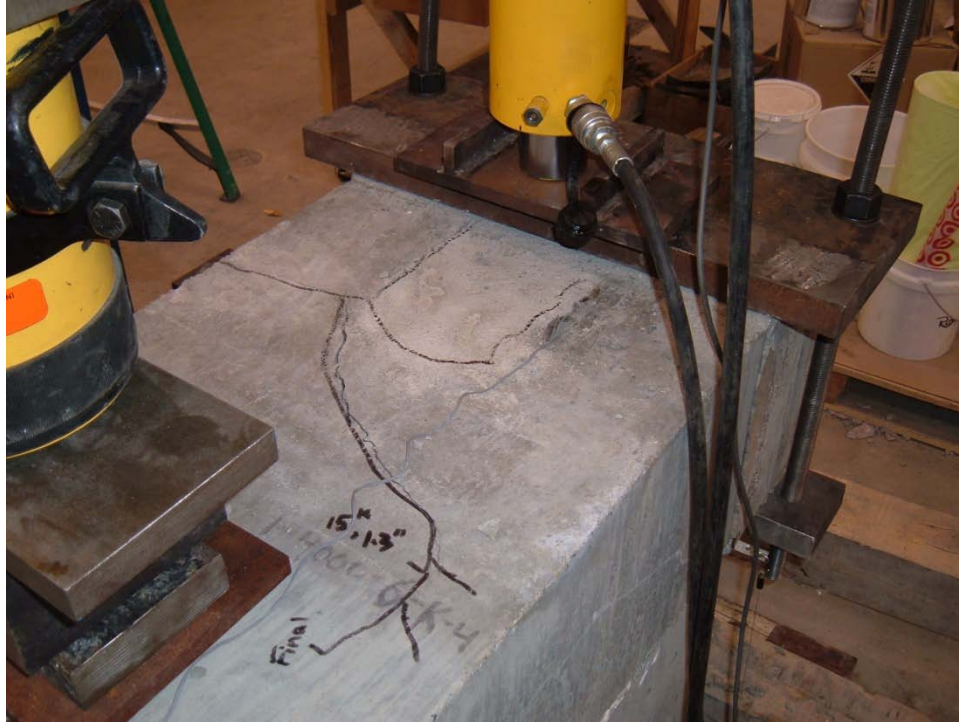
Figure 3.18: Cracking of girder section (1-4000-6-k-4)

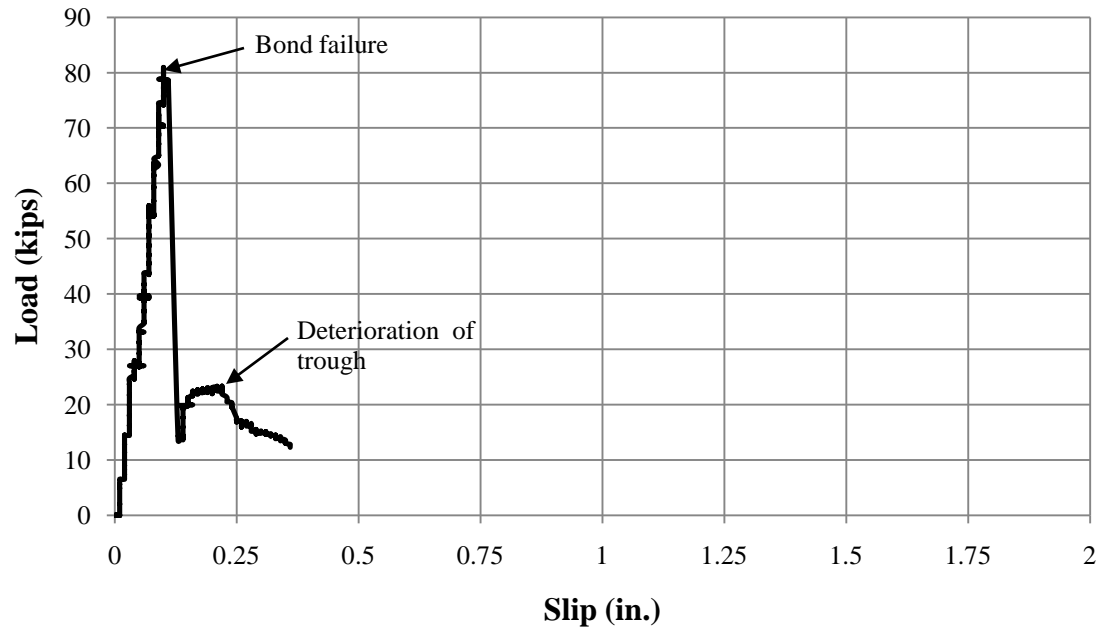
The load-slip response for Specimen 1-4000-6-k-6 is presented in Figure 3.19. The specimen behaved as a composite section up to a load of approximately 81 kips at which bond failure occurred at the panel-haunch interface. Prior to bond failure, a crack was observed at the base of the trough at a load of 27 kips. The crack propagated into the girder section initiating at the inside corners of the trough. Additional cracks developed within the trough material immediately following bond failure. Loading of the specimen continued and cracks within the trough material widened (Figure 3.20). Deterioration of the trough capacity is evident in considering Figure 3.19. A maximum measured shear stud strain of $24 \mu\epsilon$ occurred immediately prior to bond failure. The strain gauge failed once bond failure occurred.

Figure 3.19: Load-slip response of Specimen 1-4000-6-k-6

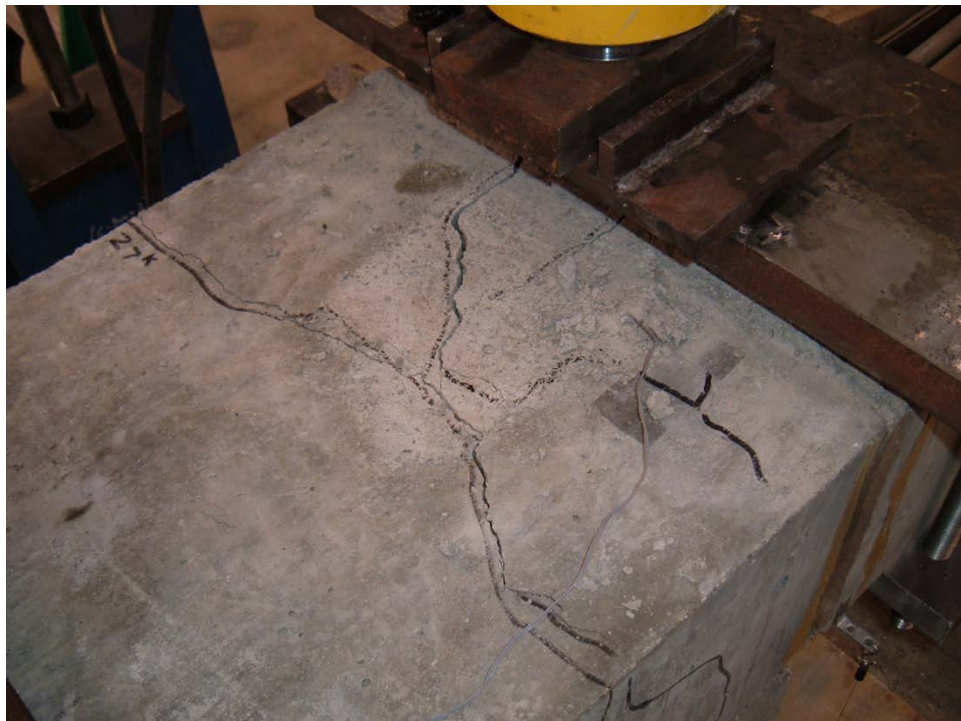
Figure 3.20: Cracking of girder section (1-4000-6-k-6)

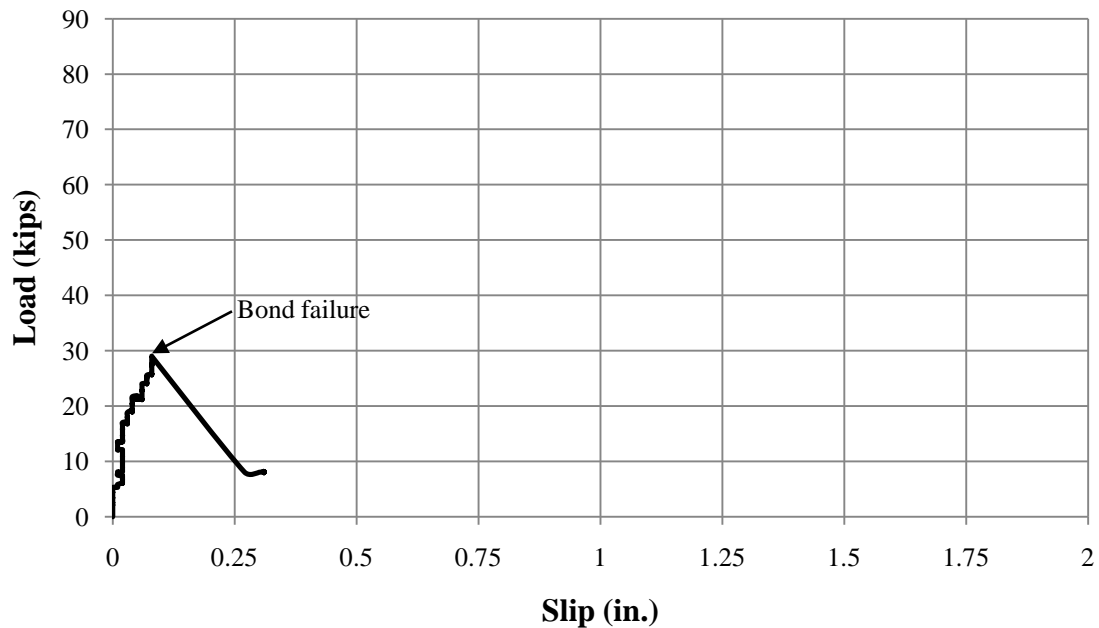
The load-slip response for Specimen 1-4000-8-6 is presented in Figure 3.21. The specimen was loaded to a maximum load of approximately 29 kips at which bond failure occurred at the trough-girder section interface. Prior to bond failure, a crack was observed at the base of the trough. The crack propagated into the girder section initiating at the inside corners of the trough. Following bond failure, the panel section began to rotate away from the girder section (Figure 3.22). The panel section continued to rotate without an increase in applied load. The test was halted once the rotation of the panel section exceeded the limits of the test setup. A maximum measured shear stud strain of $795 \mu\epsilon$ occurred after bond failure. Measured strains indicate that the shear stud did not yield.

Figure 3.21: Load-slip response of Specimen 1-4000-8-6

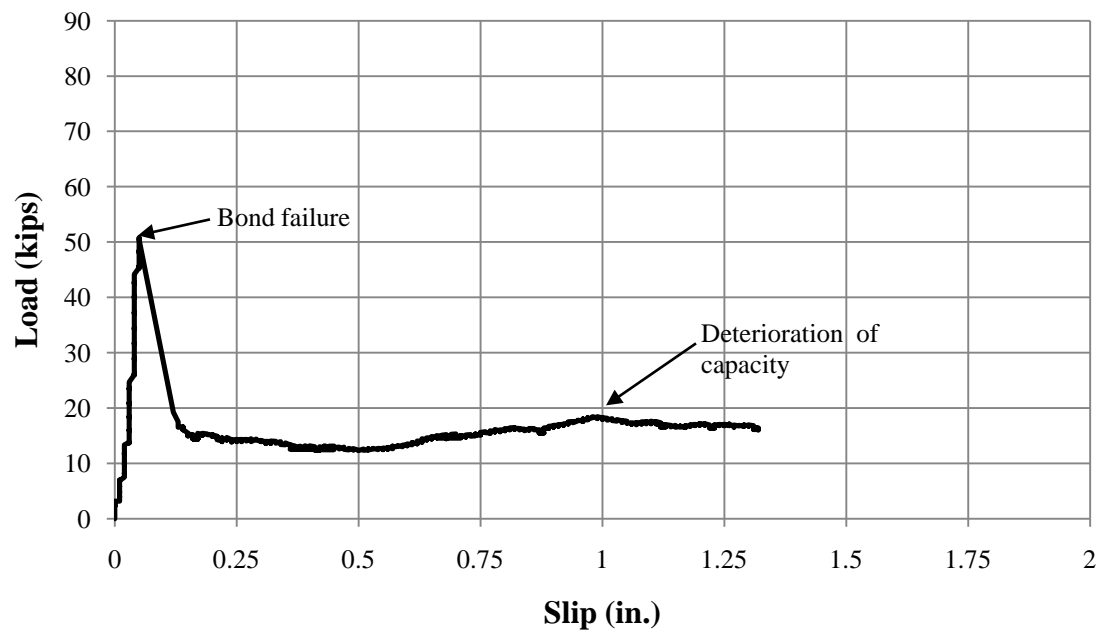
shear stud strain of $98 \mu\epsilon$ occurred immediately prior to bond failure. The strain gauge failed once bond failure occurred.

Figure 3.23: Load-slip response of Specimen 1-4000-8-k-6

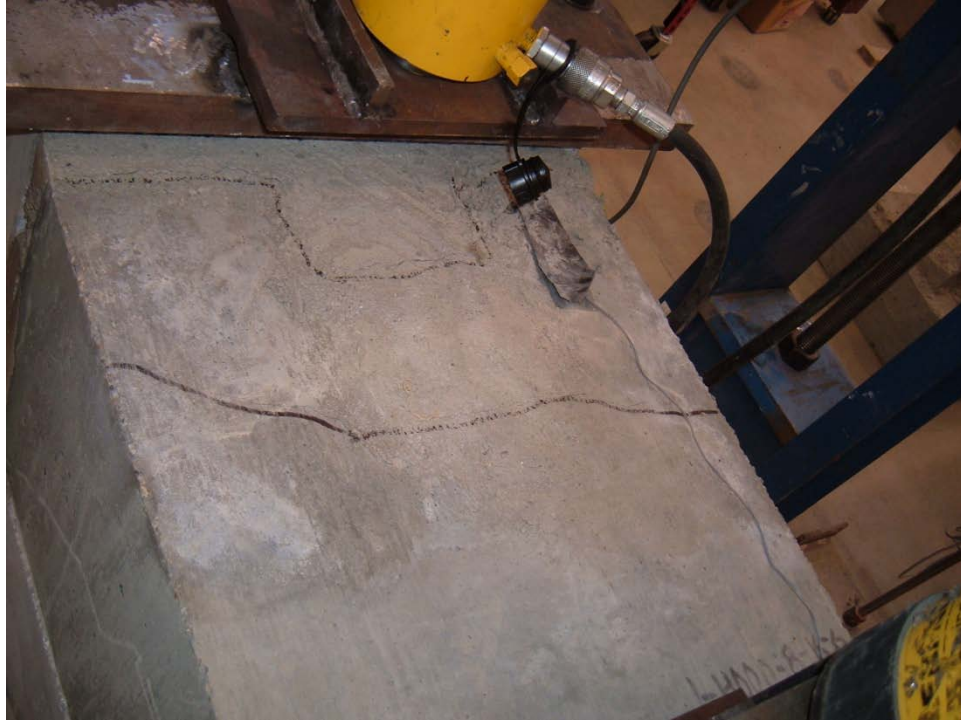
Figure 3.24: Cracking of Specimen 1-4000-8-k-6 after bond failure

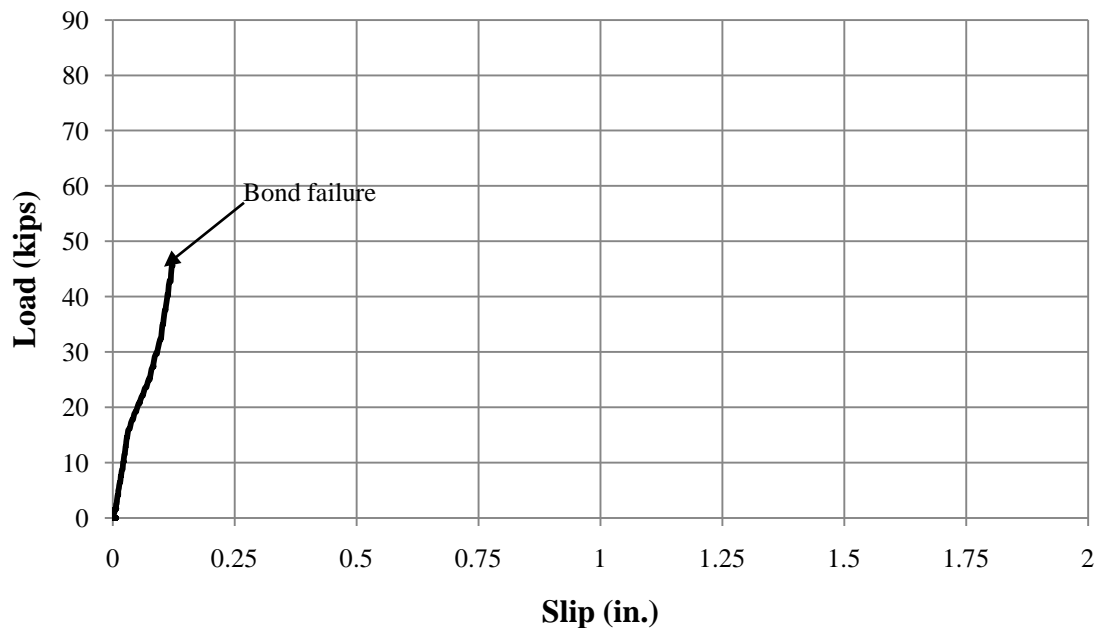
The load-slip response for Specimen 1-8000-6-4 is presented in Figure 3.26. The specimen behaved as a composite section up to a load of approximately 45.9 kips at which bond failure occurred at the trough-girder section interface. The panel and trough material completely separated from the girder section (Figure 3.27). A maximum measured shear stud strain of $7216 \mu\epsilon$ occurred after bond failure (Figure 3.28). A flexural crack was observed in the girder section at 25 kips due to uneven seating of the specimen on the support block. However, no other cracks were observed prior to bond failure.

Figure 3.26: Load-slip response of Specimen 1-8000-6-4

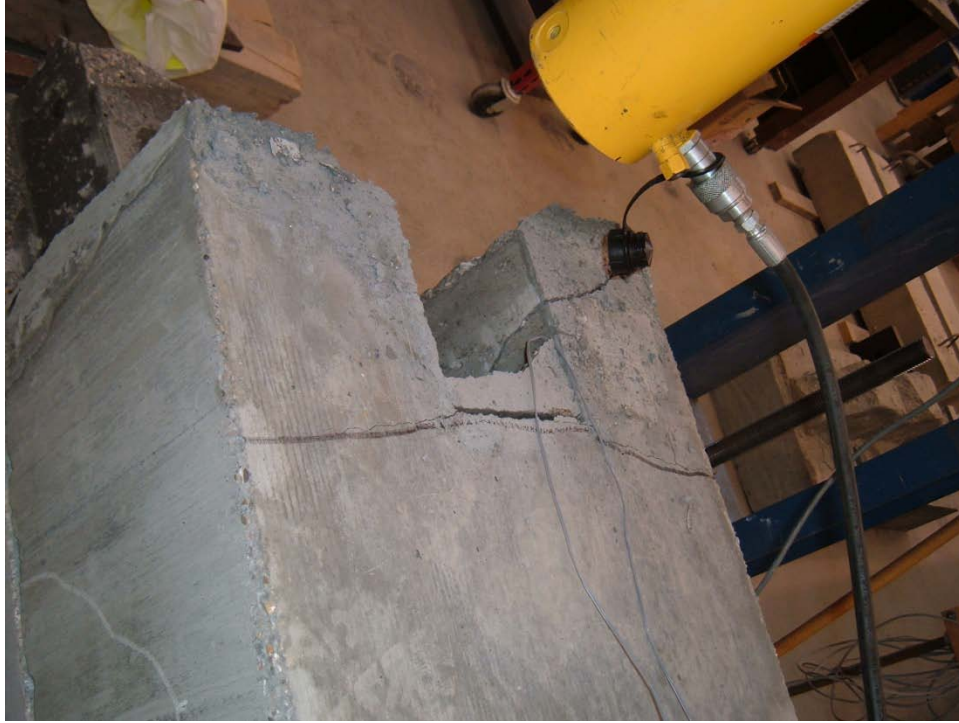
Figure 3.27: Panel separation following bond failure (1-8000-6-4)

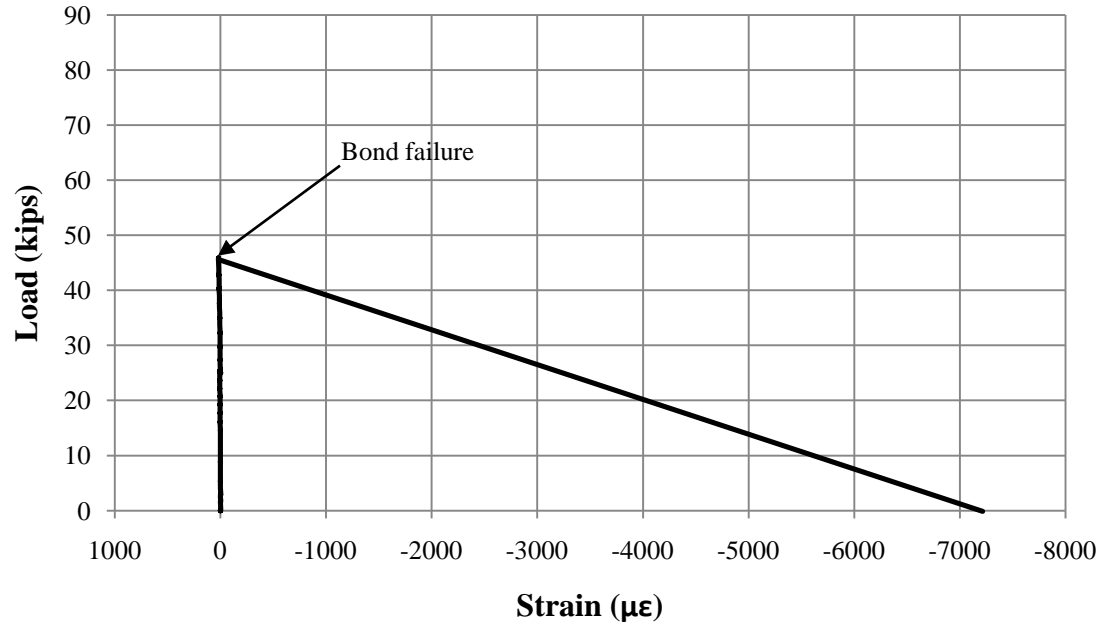
Figure 3.28: Measured shear stud strain (1-8000-6-4)

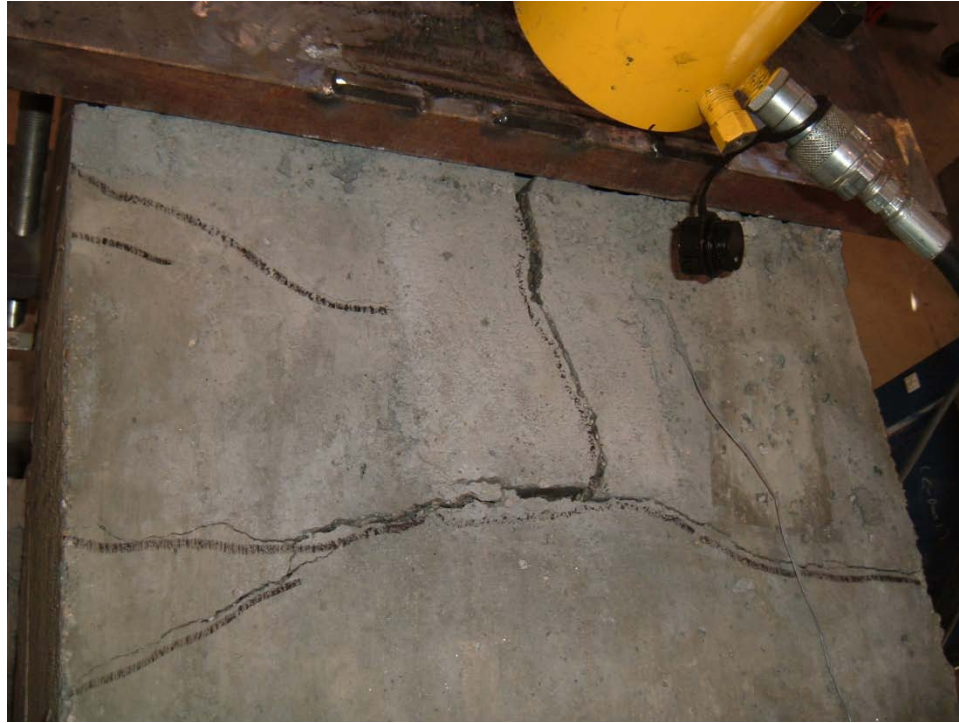
Figure 3.30: Cracking of girder section and trough (1-8000-6-k-4)

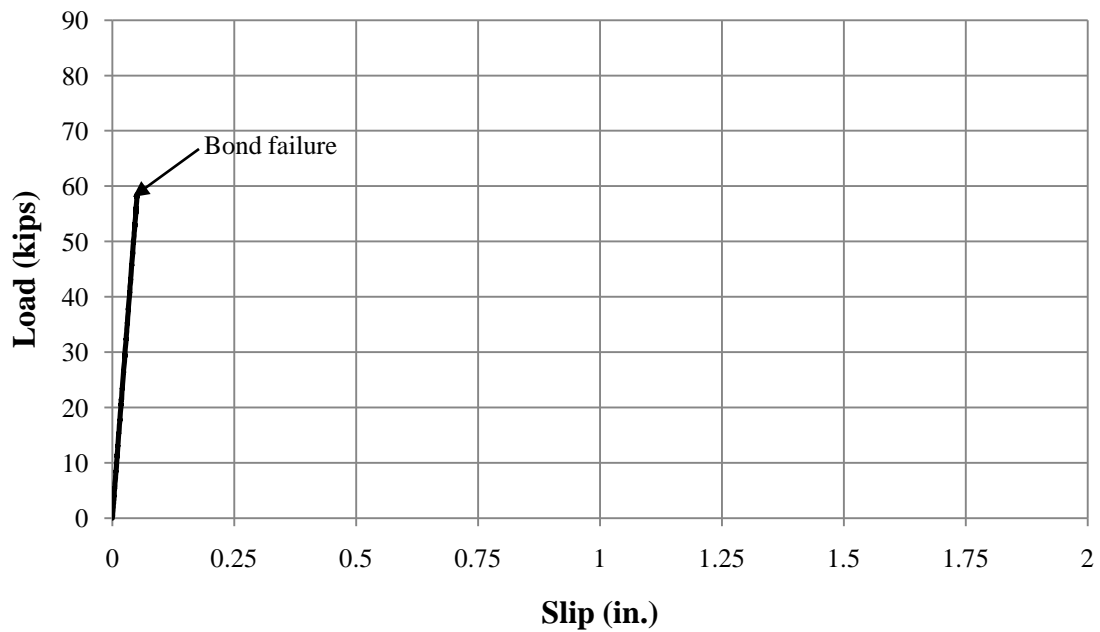
which bond failure occurred at the trough-girder section interface. The panel and trough material completely separated from the girder section. No cracks were observed prior to bond failure. A maximum measured shear stud strain of $69\ \mu\epsilon$ occurred immediately prior to bond failure. The strain gauge failed once bond failure occurred.

Figure 3.32: Load-slip response of Specimen 1-8000-6-6

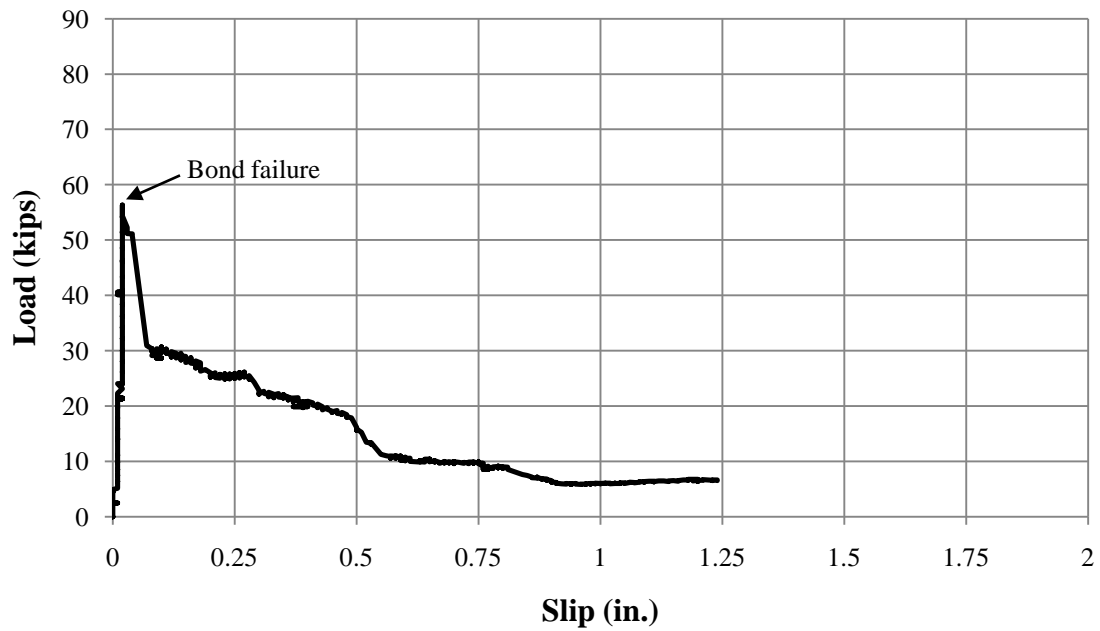
Figure 3.34: Load-slip response of Specimen 1-8000-6-k-6
